GEOTECHNICAL REPORT

Phoenix V Condominium
c/o Coastline Management LLC.
Front Lobby Foundation Evaluation Project
Orange Beach, Alabama

Thompson Engineering Project No.: 21-1102-0146

December 1, 2021

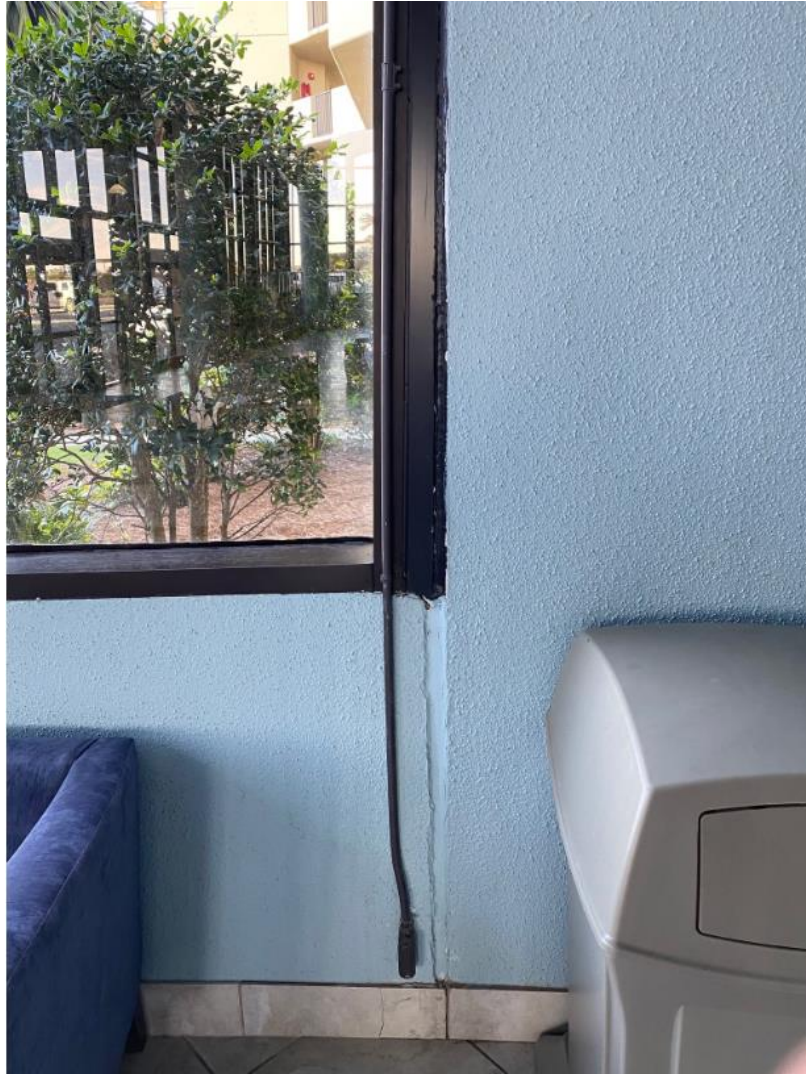
Figure 1: Front Lobby and Condominium Separation

Thompson visited the project site to observe and document the existing settlement concerns within the condominium front lobby. During our site visit, we observed the separation of the front lobby from the main condominium structure. As seen in **Figure 1** below, the existing front lobby structure has separated from the main condominium structure creating a gap that has been filled with grout and painted to match the existing frame color.

It is our engineering opinion that the settlement experienced at the project site is the result of settlement of the loose sands encountered below the slab which extend to depth of up to 12 feet below the ground surface. Likely the application of footing and slab loads and the repeated inundation of the loose sands has caused the settlement.

Remediation of the settlement should involve the design and construction of deep foundation elements that transfer the foundation loads to the dense soils beneath or ground improvement measures to prevent further settlement. While each of these systems are typically proprietary, in our experience, deep foundation elements such as helical piles or micropiles can be successfully installed to prevent further settlement of the shallow founded structure. These systems can be installed using low overhead equipment, thereby preserving most existing structure. The design of a helical or micropile support system should be performed by a Structural Engineer. Once foundation design loads have been determined, Thompson's

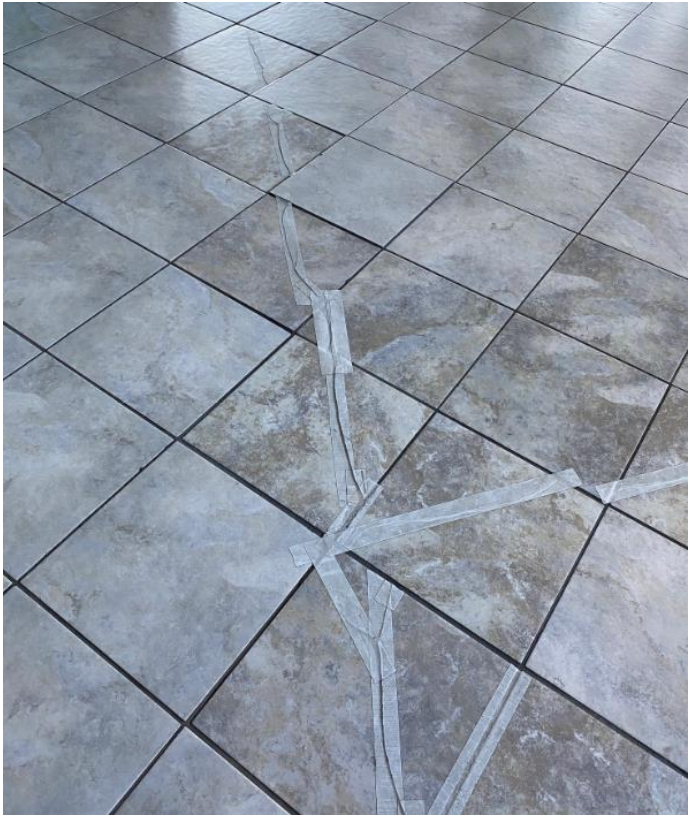
Figure 2: Front Lobby Tile Cracking

In addition, various cracking was visible within the ground floor tile installed in the front lobby. The extent of the tile cracking can be seen in **Figure 2**, presented below.

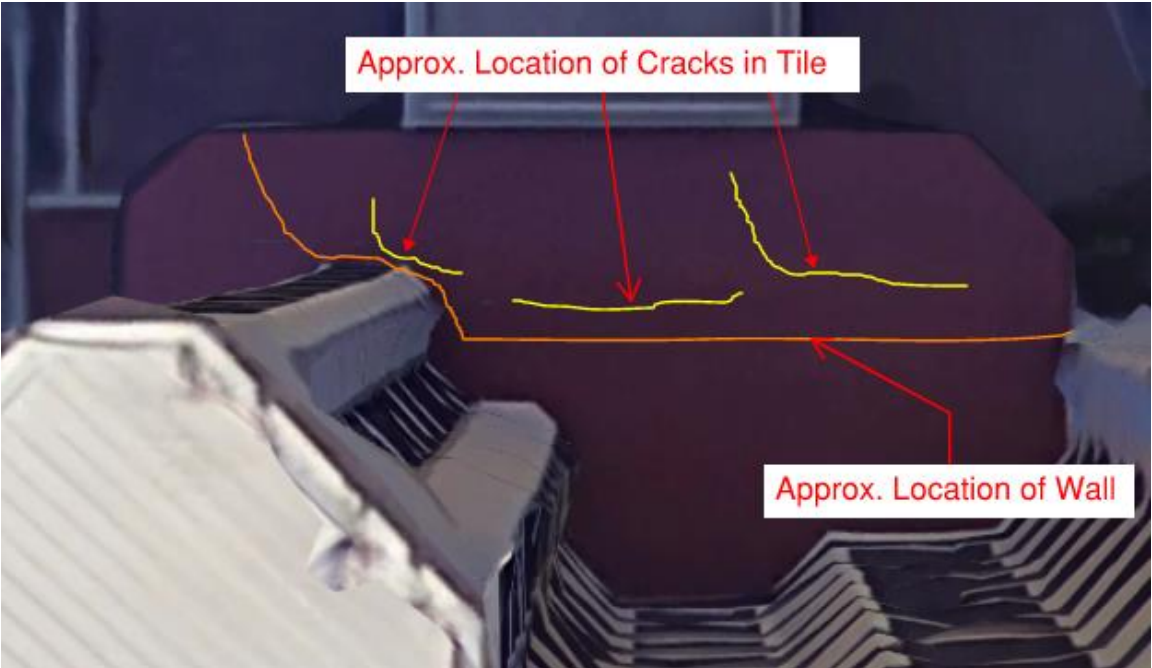
Figure 3: Overview of Front Lobby

An overview of the ground floor lobby showing the approximate locations of the tile cracks and condominium support wall are presented in **Figure 3** below.
