Mr. Nicolas Chauvin
Escambia County BOCC - Engineering Department
3363 West Park Place
Pensacola, FL 32505

September 11, 2025
Project No.: M25-454

Re: Pre-Demolition Asbestos Survey Report
Bob Sikes Bridge Toll Plaza
401 Pensacola Beach Blvd.
Gulf Breeze, FL 32561

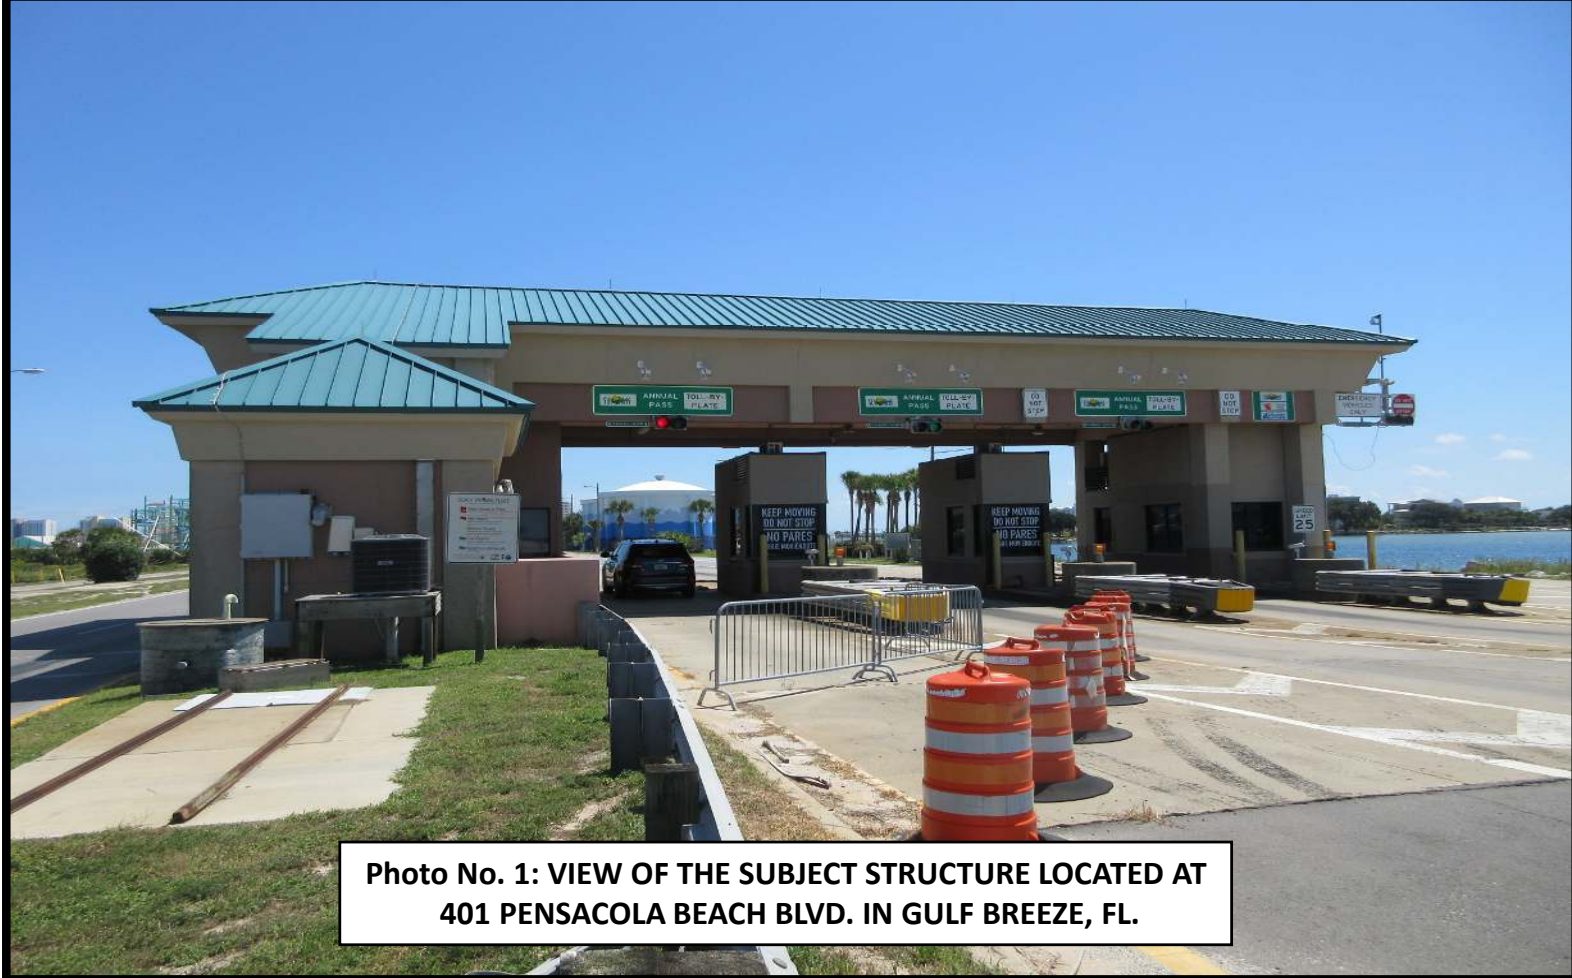
Photo No. 1: VIEW OF THE SUBJECT STRUCTURE LOCATED AT 401 PENSACOLA BEACH BLVD. IN GULF BREEZE, FL.

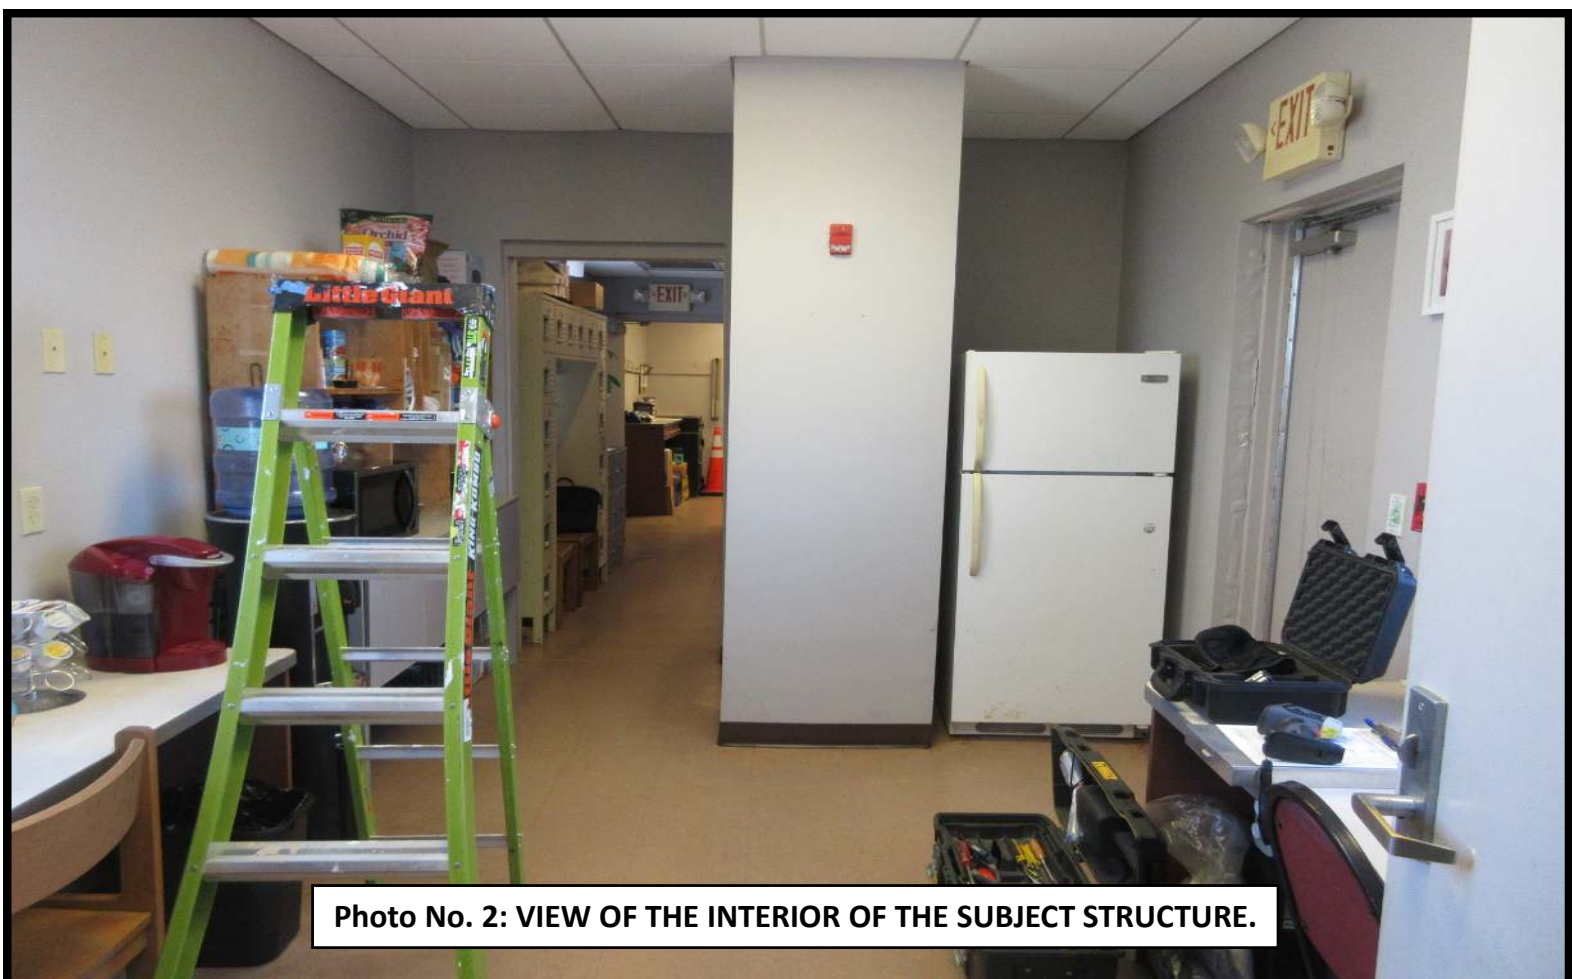
Photo No. 2: VIEW OF THE INTERIOR OF THE SUBJECT STRUCTURE.
