Project No.: M25-454

Re: Pre-Demolition Lead-Based Paint Survey Report

Bob Sikes Bridge Toll Plaza 401 Pensacola Beach Blvd. Gulf Breeze, FL 32561

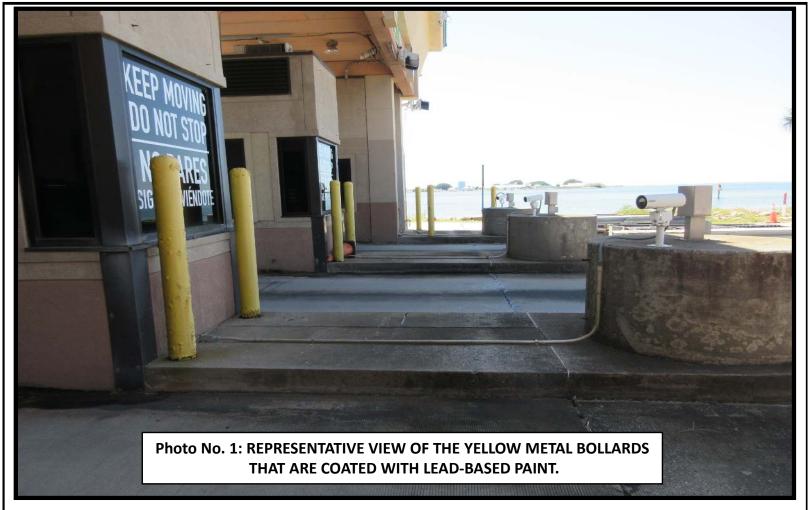
Sample Number	Component Description	Component Location	BGS	PC	XRF Reading (mg/cm²)
045	Brown Door Frame	Exterior	М	ı	0.1
046	Brown Gutter	Exterior	М	ı	0.1
047	Tan Wall	Exterior	S	ı	0.0
048	Black Windowsill	Exterior	М	ı	0.0
049	Yellow Bollard	Exterior	М	ı	2.4
050	Yellow Bollard	Exterior	М	ı	1.8
051	Tan Wall	Exterior	S	ı	0.3
052	Brown Wall	Exterior	S	ı	0.2
053	Yellow Striping	Roadway	С	ı	2.9

- Exterior Yellow Metal Bollards (Photograph No. 1)
- Exterior Yellow Road Striping (Photograph No. 2)

A case by case assessment of each construction activity should be conducted to determine which components should be abated prior to disturbance. The assessment should include an evaluation of the type of work that will be conducted (i.e. drilling, sawing, demolition, repainting etc.), the concentration of lead detected in the painted surface, and the results of any available prior negative exposure air monitoring data. Contractors should follow these regulations when working with lead painted components and avoid activities (sanding, torch cutting, grinding, abrading) which could produce lead fume or respirable dust.

The EPA requires that solid waste containing lead be tested using the Toxicity Characteristic Leachate Procedure (TCLP) for lead to determine if the waste must be disposed of as hazardous waste. A composite sample of any paint-chips and building components known to contain lead should be analyzed using the lead TCLP before disposing of such waste. If the laboratory results for the TCLP analysis are greater than 5.0 milligrams per liter (or 5.0 parts per million), the waste will be considered hazardous and must be properly disposed of as hazardous waste. Metal components coated with lead-based paint may be disposed of at a recycling facility as scrap metal.
