CORNERSTONE FACILITIES ENGINEERING, INC.

INDIGO CONDOMINIUMS GARAGE LEVEL SERVICE ELEVATOR LOBBIES PROJECT May 3, 2022 Revision 1 May 25, 2022

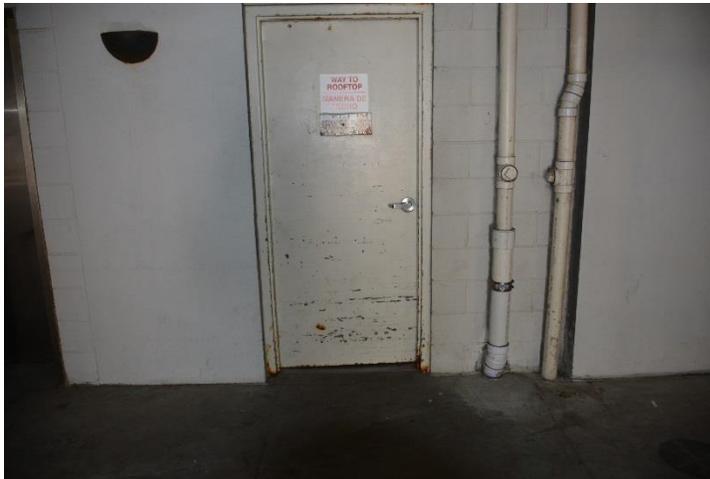
Exterior of the West Building's -01 & -02 Stack Service Lobby Door. This door and frame to be removed and replaced with a new 3⁶X7⁰ door and frame. New lever set, non-locking, to be included.

For the -01 & -02 door of the West Building's stack 01 & -02 Service Lobby, demolish the existing door and frame. Modify rough opening as required. Procure and install a hollow-core metal door and frame. Door and frame to have an 18-gage galvanized steel construction. New lever style lock set and stainless steel hinges to be used. Hydraulic closer to be provided and installed. The new doors and frames are to be 3⁶X7⁰.

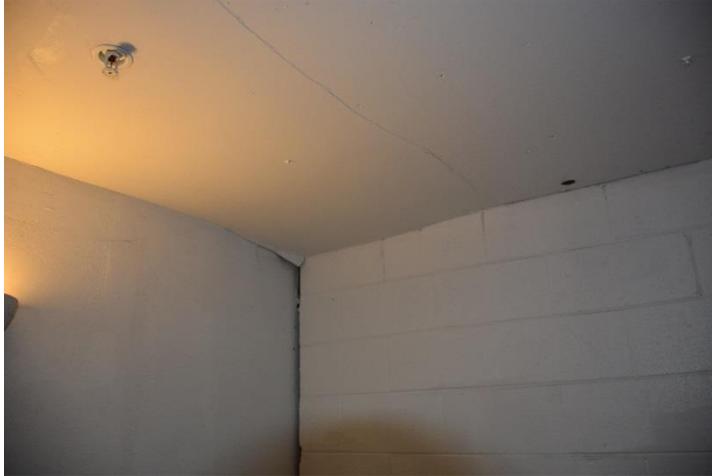
Interior of West Building's -01 & -02 Stack service elevator lobby. Gypsum board ceiling to be demolished. Sprinkler head (and hear-detector, not shown) to be mounted at bottom of concrete elevation once ceiling is removed. Bottom of concrete to be primed and painted (white in color.) Gaps in CMU wall corners to be detailed by backer rod and urethane sealant. Walls to be prepared and painted with two coats of acrylic paint.

Demolish and dispose of existing gypsum board ceilings. Relocate the existing sprinkler head and heat detector to the bottom of concrete (similar to existing conditions in the East Building's Service Lobbies. For the existing opening in the bottom of concrete (which will be seen when the gypsum board is removed) of the ceiling slab, install a 3/4-inch thick section of Durock cement board. Secure Durock to concrete with six, 1/4-inch diameter by 2-inch long, stainless steel Tapcons. Apply fire caulking (3M or Hilti) about perimeter of Durock to ceiling joint. Prepare and paint existing ceiling. Apply two coats of BASF HB200. Remove the existing fire dampers and cover openings with patches fabricated from 1/2-inch Durock cement board secured to the CMU walls with Tapcons.

For joints between ceiling and walls and wall-to-wall, install backer rod as needed and seal with NP1 urethane sealant. Fire caulk any pipe penetrations through the walls with 3M or Hilti sealant. Prepare and paint using two coats of BASF HB200 acrylic paint. Protect fire dampers.

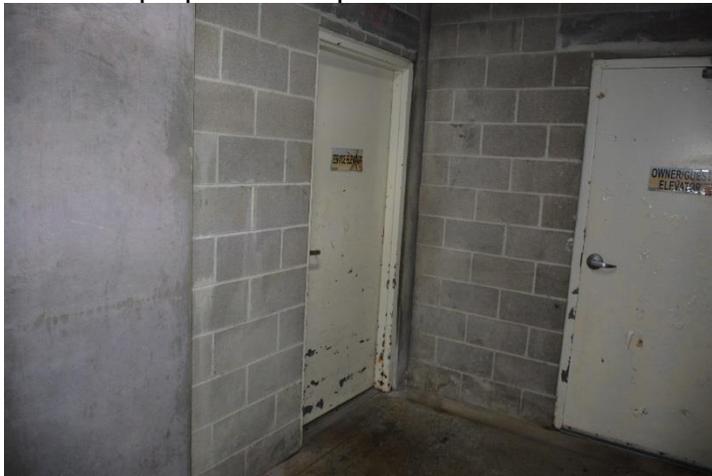
Exterior of service elevator lobby entrance door for West Building, -03 & -04 Stacks. This door and frame to be sanded, primed and then receive two coats of paint.

For doors that are to remain, sand both sides of doors and frames. Solvent wipe. Prime with Sherwin-Williams Corothane Mio-Al primer. Paint using two coats of Sherwin-Williams Sher-Cryl HPA high performance acrylic paint.

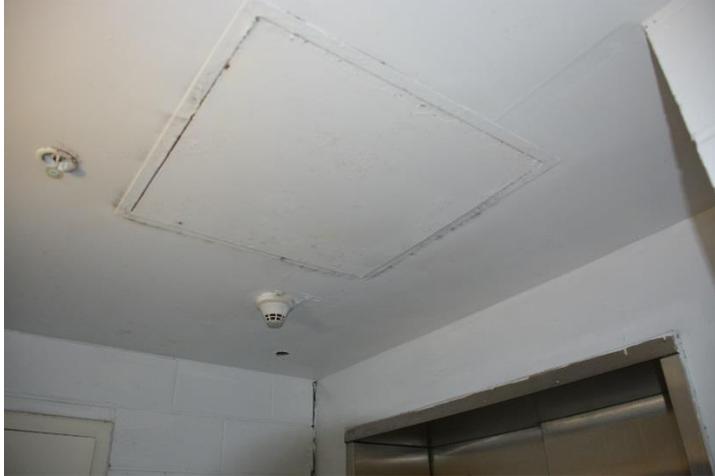
Interior of West Building -03 & -04 service elevator lobby. Sprinkler head and heat detector to be mounted at bottom of concrete elevation once ceiling is removed. Bottom of concrete to be primed and painted (white in color.) Gaps in CMU wall corners to be detailed by backer rod and urethane sealant. Walls to be prepared and painted with two coats of acrylic paint.

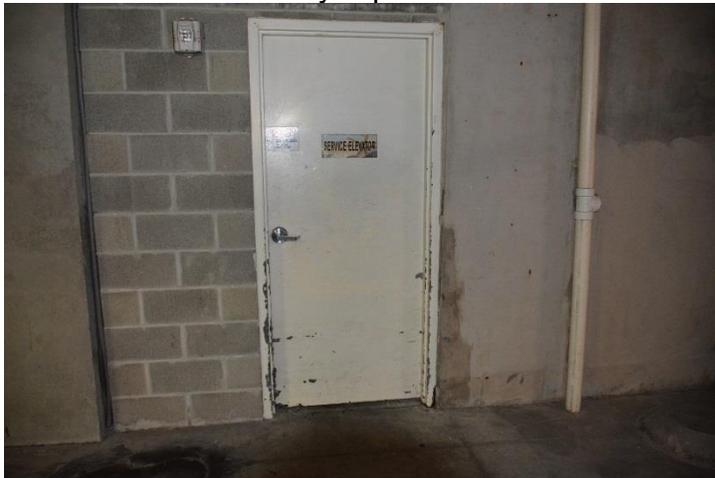
Door into East Building's -06 & -05 stacks. This door and frame to be sanded, primed and then receive two coats of paint.

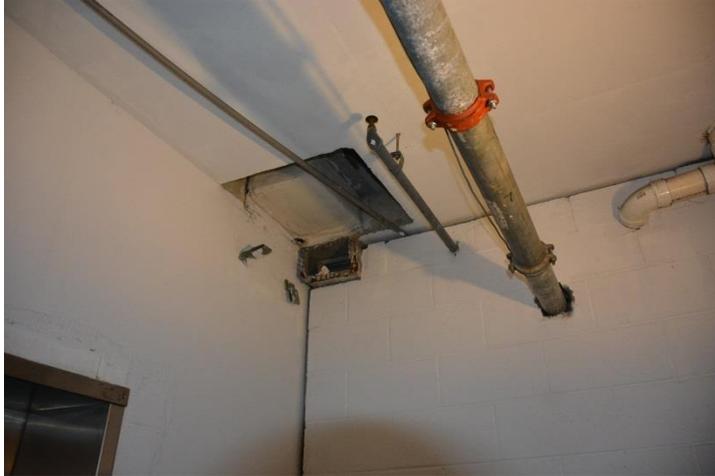
Interior of East Building's service elevator lobby for the -06 & -05 stacks. Pipe penetrations to be fire caulked (3M, Hilti or equal.) Opening in ceiling to be closed with a section of ¾-inch thick Durock (or equal.) Gaps in CMU wall corners to be detailed by backer rod and urethane sealant. Walls and ceiling to be prepared and painted with two coats of acrylic paint.

Prepare and paint existing ceiling. Apply two coats of BASF HB200. Protect sprinkler head and heat detector. For the existing opening in the bottom of concrete of the ceiling slab, install a 3/4-inch thick section of Durock cement board. Secure Durock to concrete with six, 1/4-inch diameter by 2-inch long, stainless steel Tapcons. Apply fire caulking (3M or Hilti) about perimeter of Durock to ceiling joint. Remove the existing fire dampers and cover openings with patches fabricated from 1/2-inch Durock cement board secured to the CMU walls with Tapcons.

penetrations through the walls with 3M or Hilti sealant. Prepare and paint using two coats of BASF HB200 acrylic paint. Protect fire dampers.

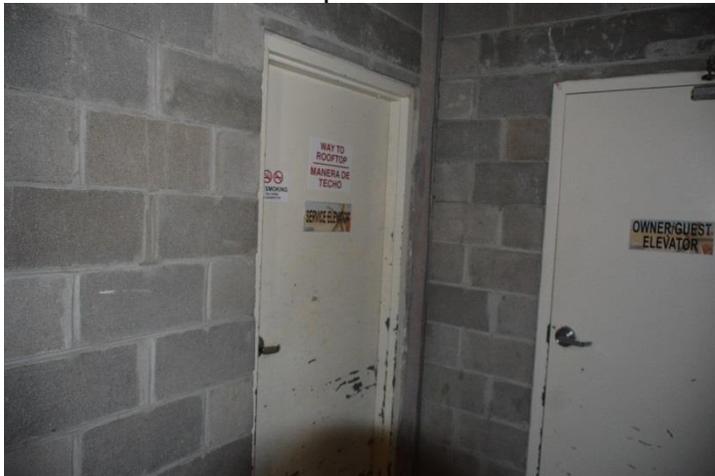
Door into the East Building's -03 & -04 Stacks. This door and frame to be removed and replaced with a new 3⁶X7⁰ door and frame. New lever set, non-locking, to be included.

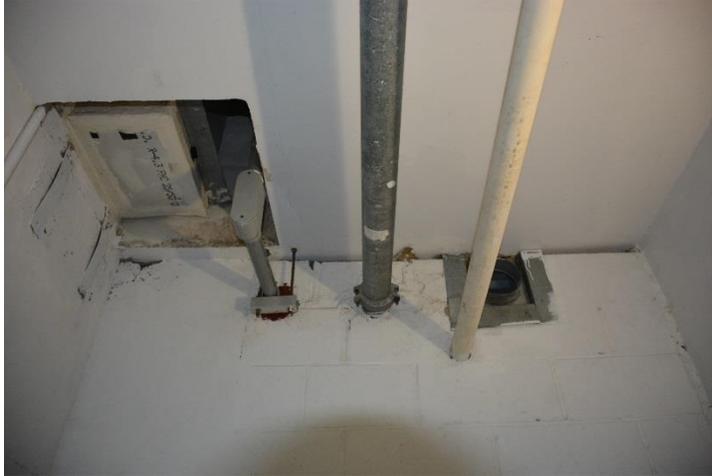
Interior of East Building's service lobby ceiling for -03 & -04 Stacks. Pipe penetrations to be fire caulked (3M, Hilti or equal.) Opening in ceiling to be closed with a section of ¾-inch thick Durock (or equal.) Gaps in CMU wall corners to be detailed by backer rod and urethane sealant. Walls and ceiling to be prepared and painted with two coats of acrylic paint.

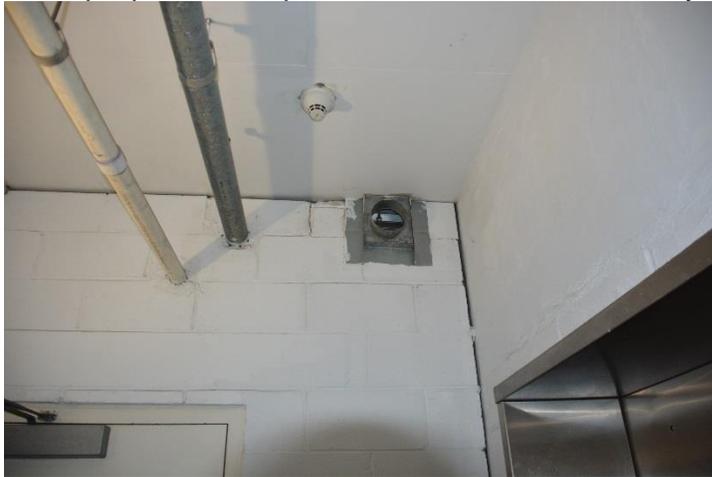
Interior of East Building's service lobby ceiling for -03 & -04 Stacks. For the East Building, the existing 6-inch diameter fire dampers are to be removed and the openings sealed using ½-inch thick, Durock, cement board patches. Durock to be placed on both sides of the wall to cover opening. For the West Building's two service elevator lobbies, a total of four, 6-inch diameter, fire dampers will need to be removed and openings covered when the ceiling is removed.

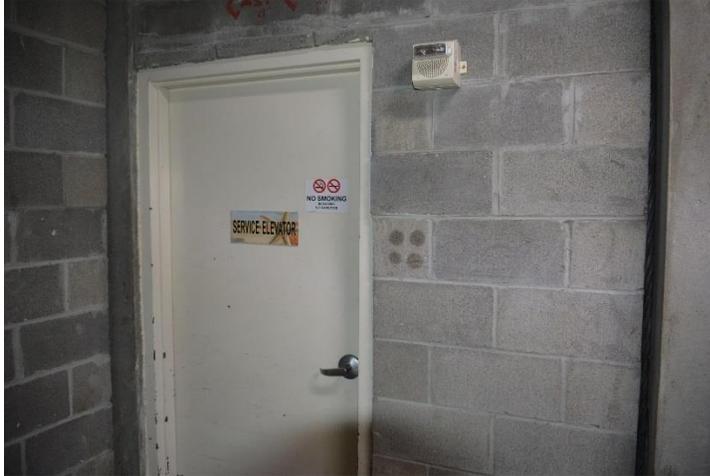
Door into the East Building's service elevator lobby for the -01 & -02 Stacks. This door and frame to be sanded, primed and then receive two coats of paint.

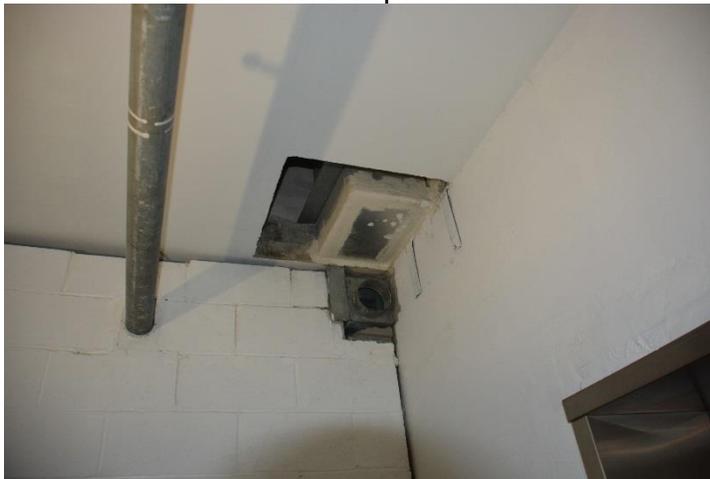
Interior of East Building's service lobby ceiling for -01 & -02 Stacks. Pipe penetrations to be fire caulked (3M, Hilti or equal.) Opening in ceiling to be closed with a section of $\frac{3}{4}$ -inch thick Durock (or equal.) Gaps in CMU wall corners to be detailed by backer rod and urethane sealant. Walls and ceiling to be prepared and painted with two coats of acrylic paint.
